PVC Module Production (2.5)

University of Minnesota

May 8, 2012

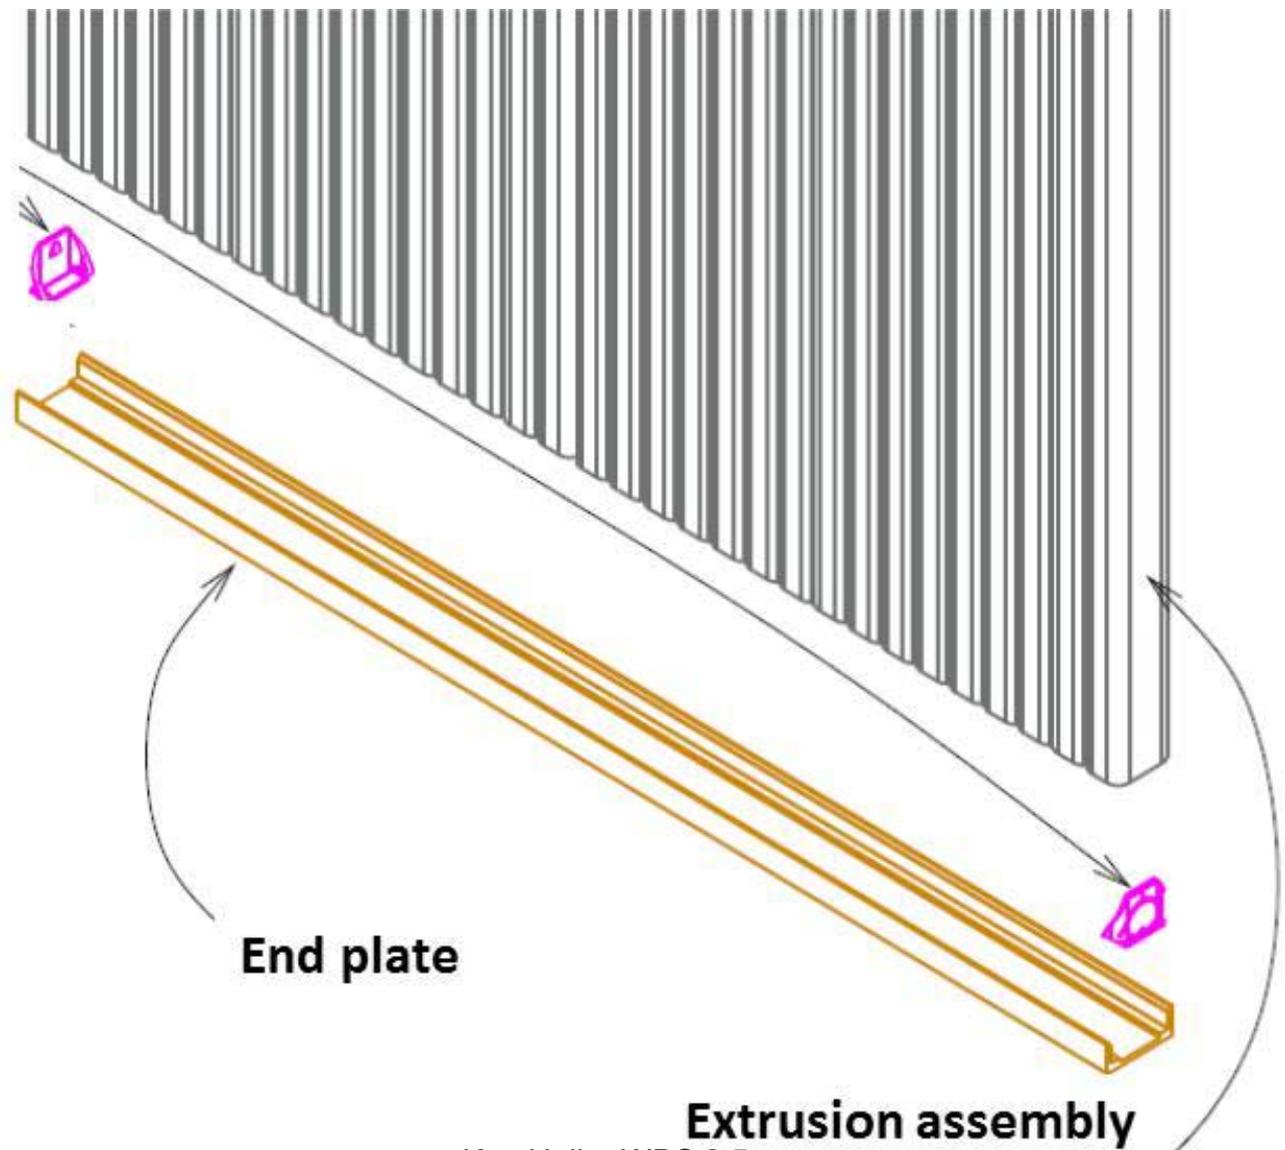
End Seal Parts

Side seals

End plate

Extrusion assembly

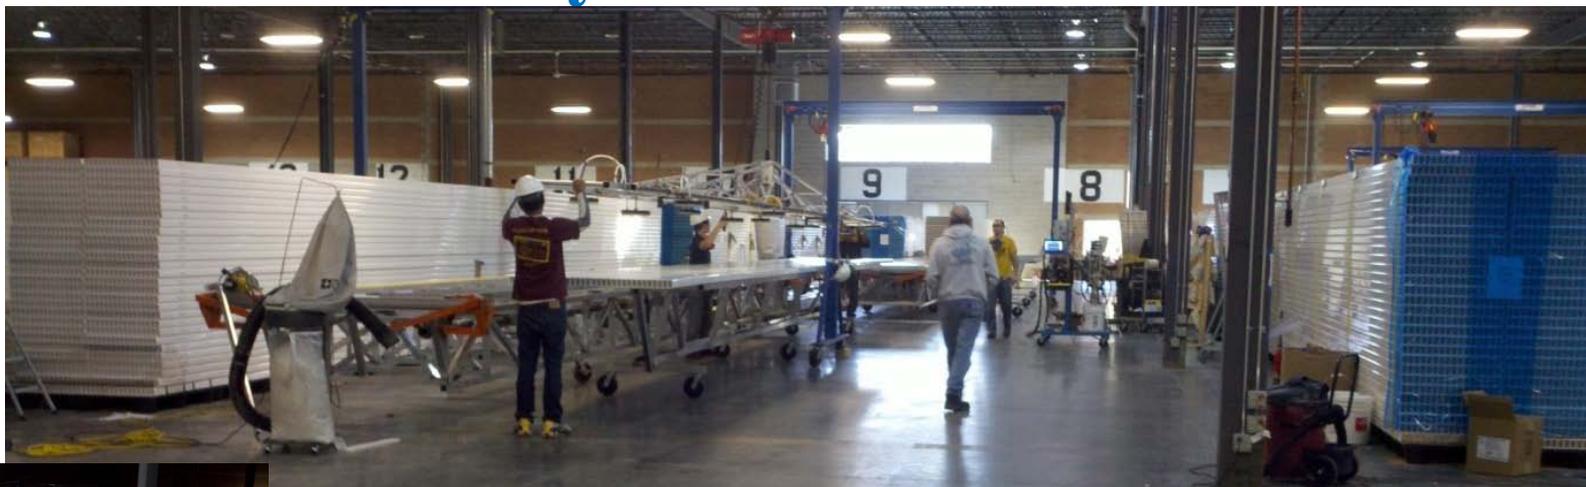
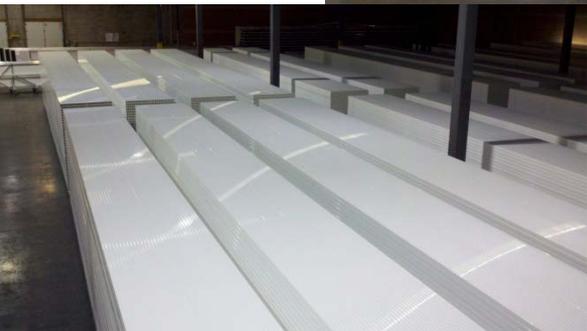
Module Factory Stable 2 to 1 Production

Peak 2 to 1 production rate 38/day (average needed 27/day)

3263 complete 2 to 1 (8.5 blocks = 29% of far detector)

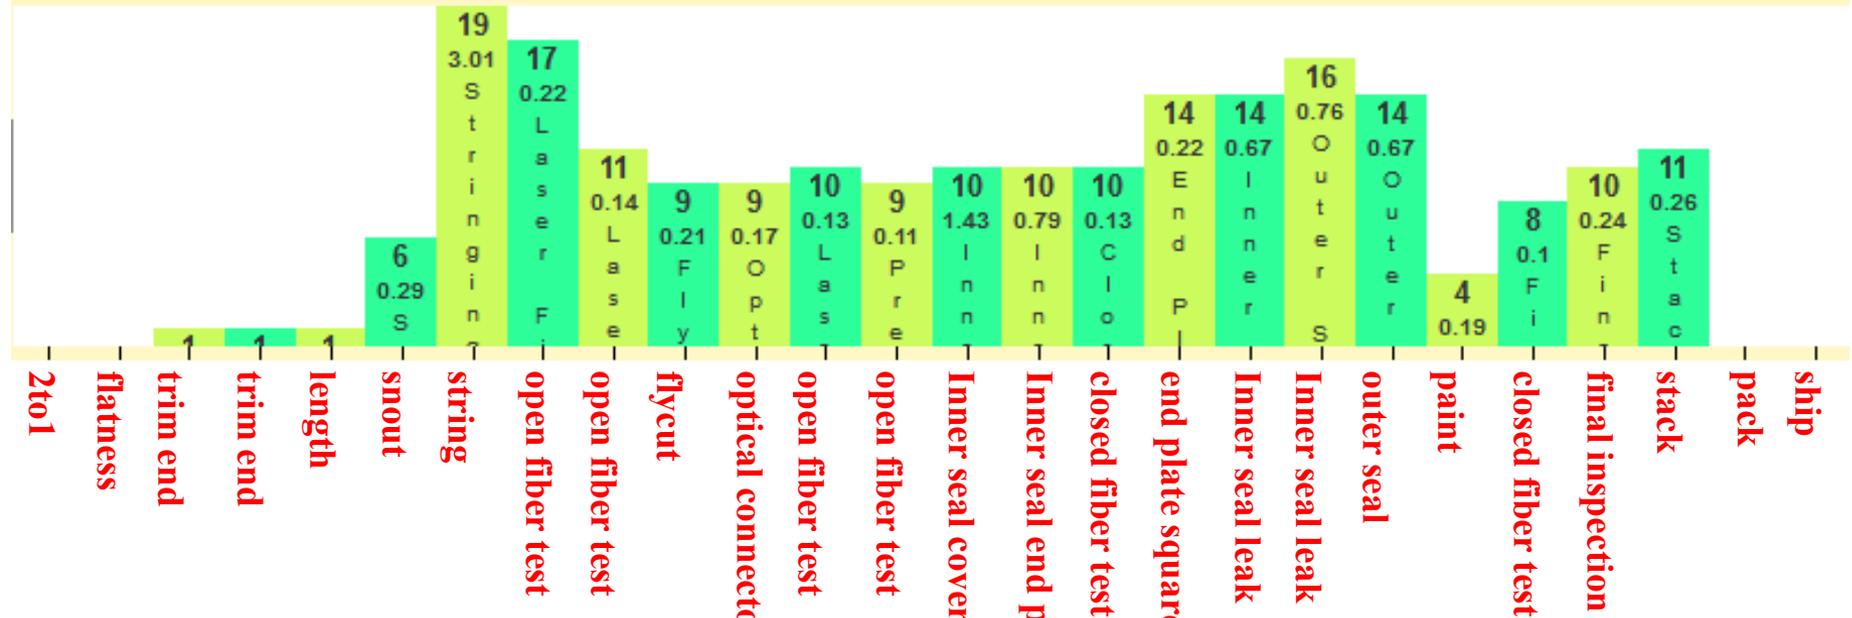
One Day Production Snap Shot

Failures week 1
 Fiber: 32
 Inner seal: 1
 Final inspection: 1

Failures week 2
 Fiber: 14
 Inner seal: 4
 Final inspection: 3
 Optical connector: 2

Failures week 3
 Fiber: 4

Week 1- produced 37 modules (92% failed QA)
Week 2 – produced 56 modules (41% failed QA)
Week 3 (2 days) – produced 16 modules (25% failed QA)

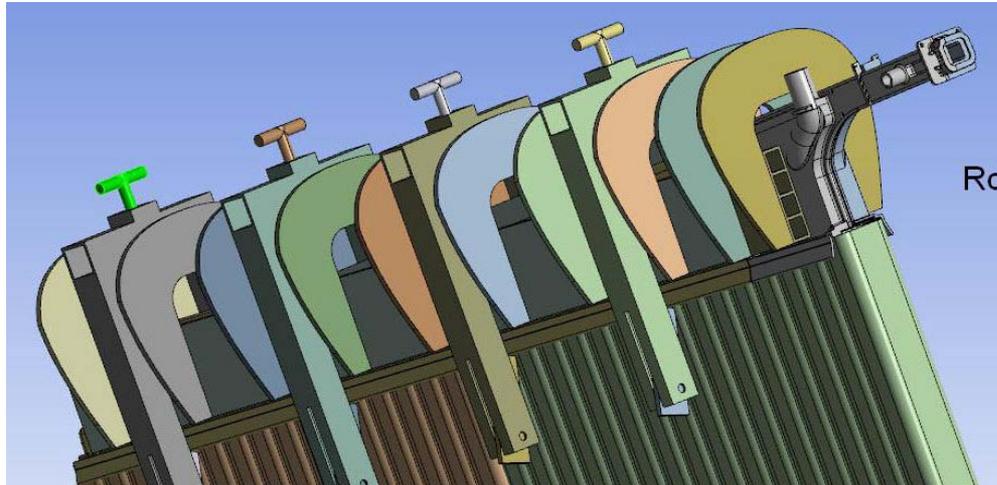
New Tooling – Cover Clamp

Ang Lee Analysis

Measured material strength between 6400 & 5100 psi.

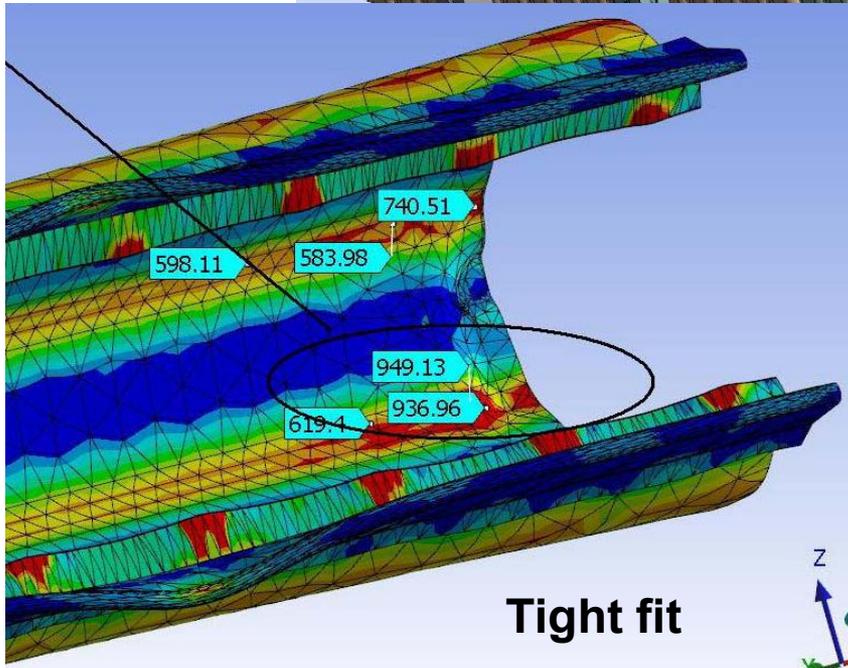
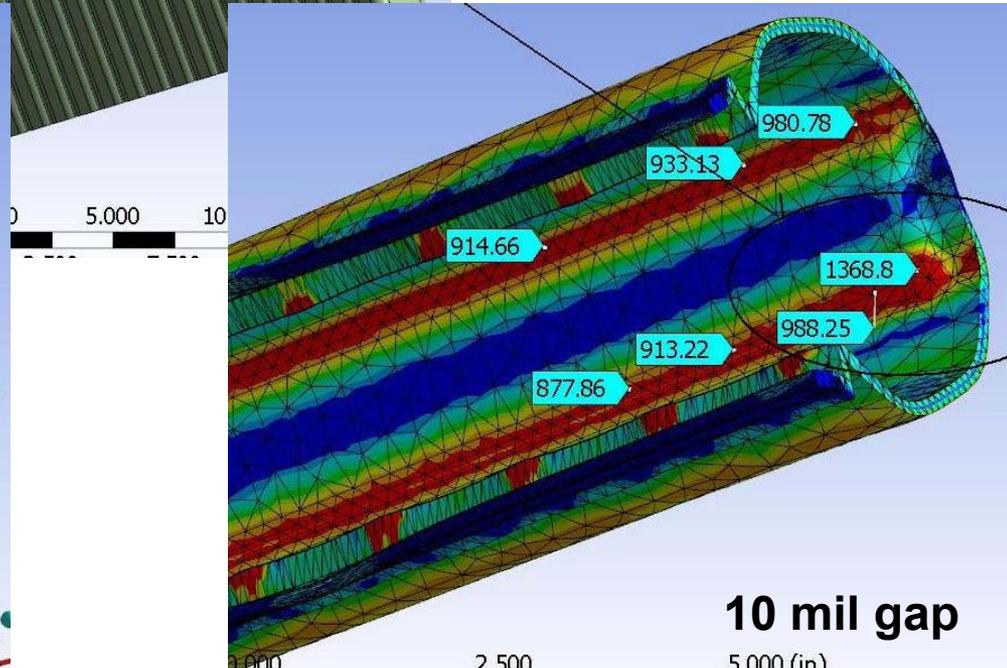
New cover and clamp design - max stress between 1000 & 1400 psi.

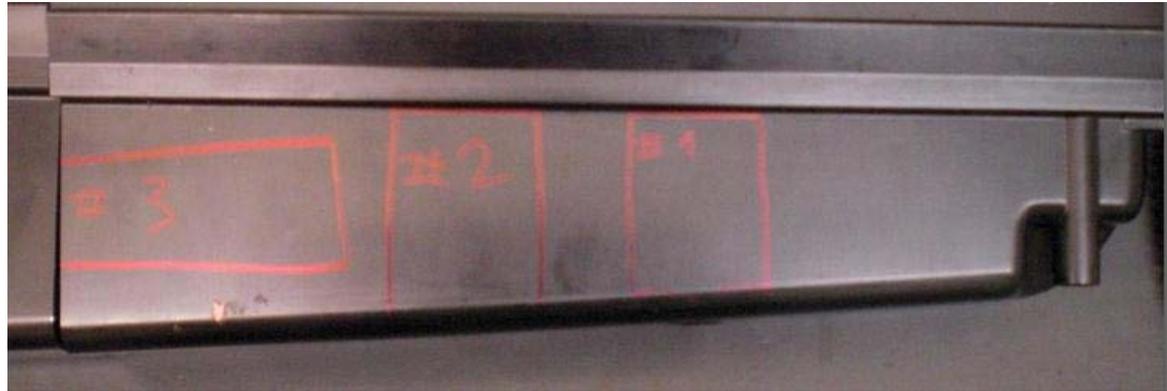
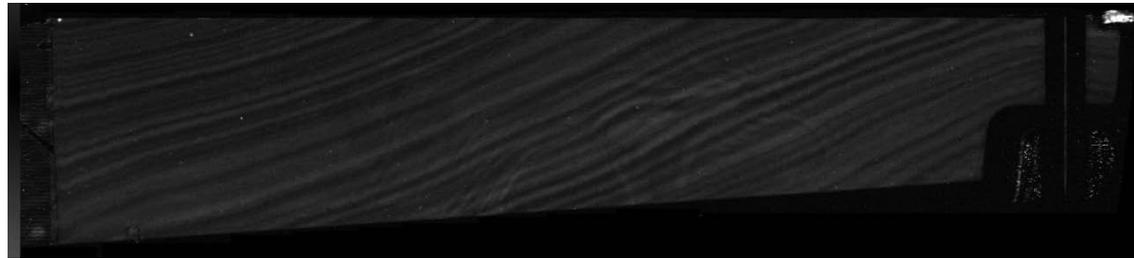
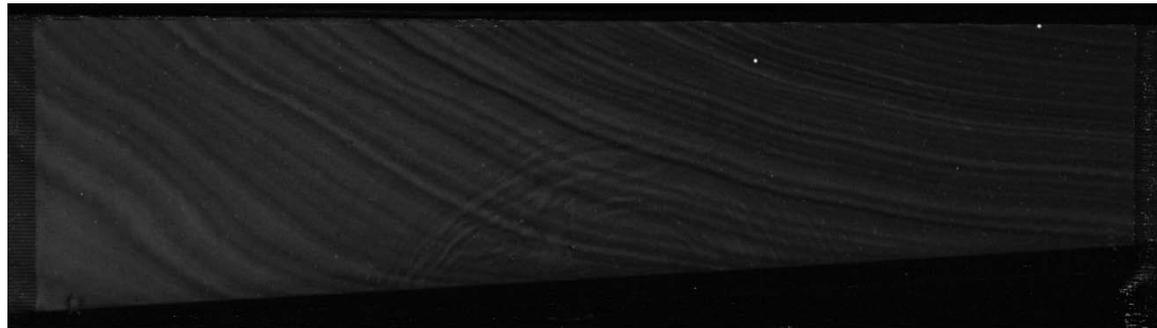
Manifold Cover Ultrasound Scans

Section 1

Section 2

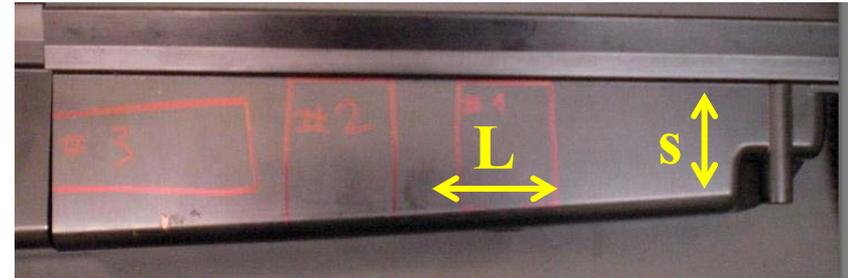
Cover Tensile Strength

Sample	Section	Direction	Max PSI
1	1	S	6448
2	1	S	5998
3	1 - 2	L	5984
4	5	L	5697
5	5	S	5963
6	2	L	5937
7	6	L	5117
8	7	S	6141
9	7	L	6105
10	7	S	6196
11	3	L	6056

Sample size: 1" x 5/32"

Pulling rate 0.15 inches/minute

Data rate 10 measurements/sec

No significant strength difference among sections

Visual inspection of cross-sections shows no difference

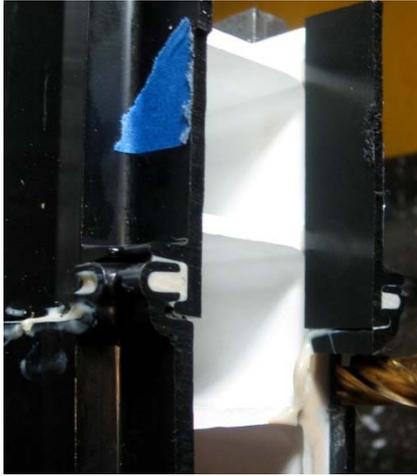
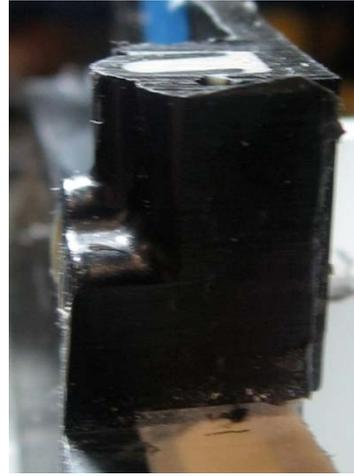
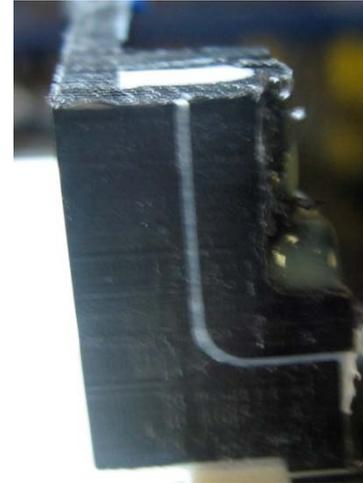
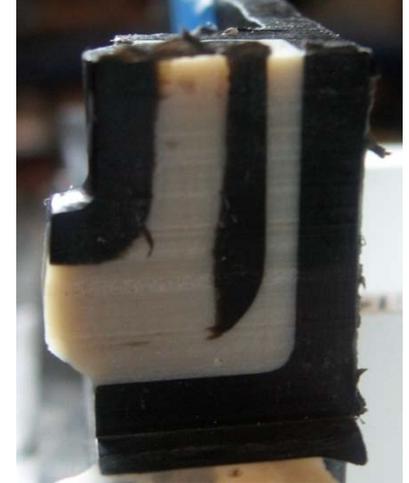
Cross section cuts to check glue flow

Snout Joints Cross-section cut every 0.05"

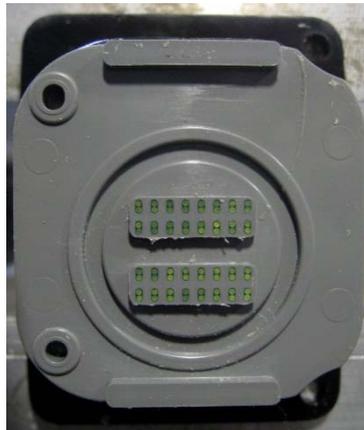
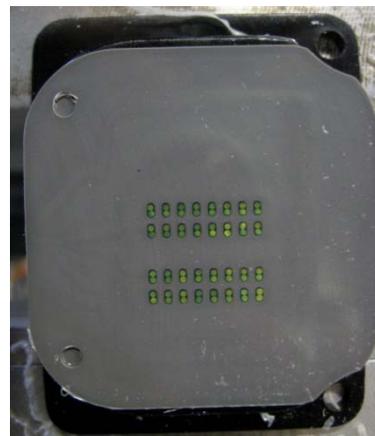
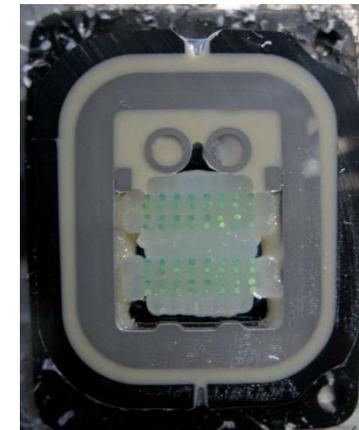
Optical connector Cross-section cut every 0.015"

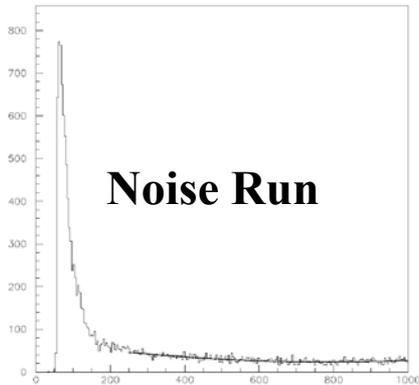
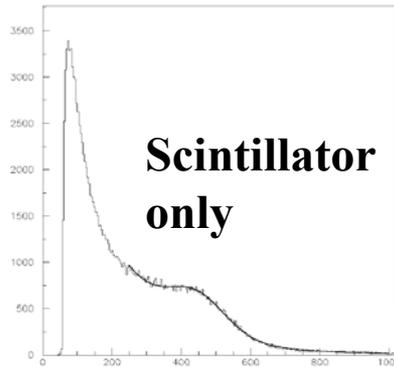
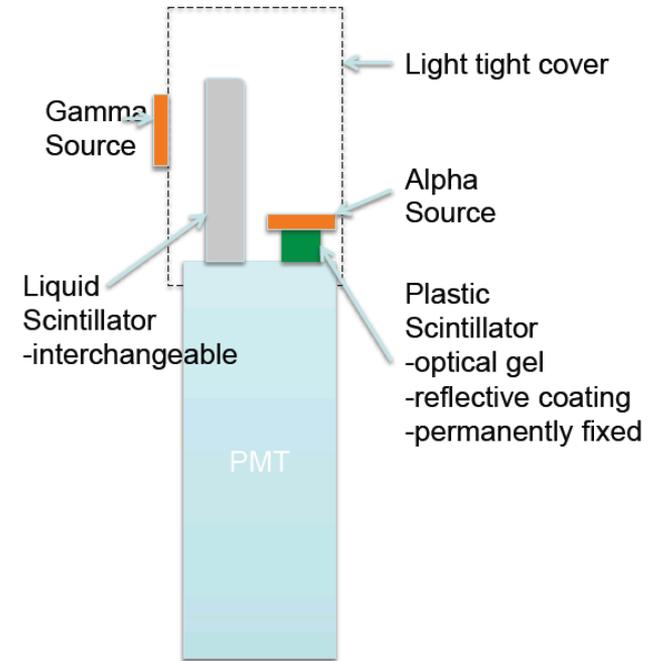
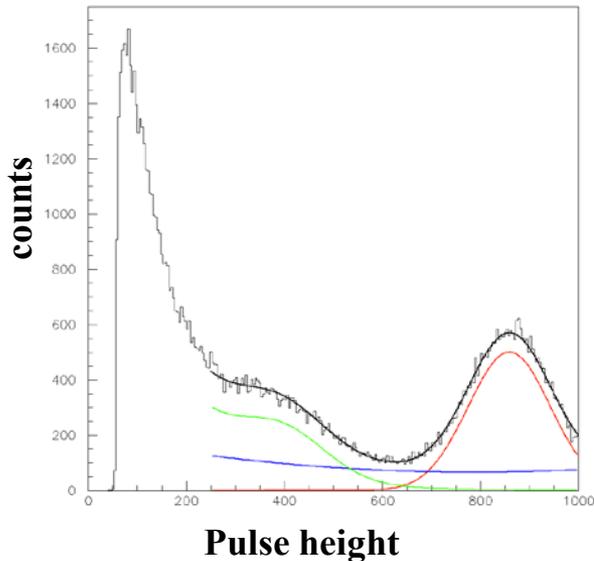
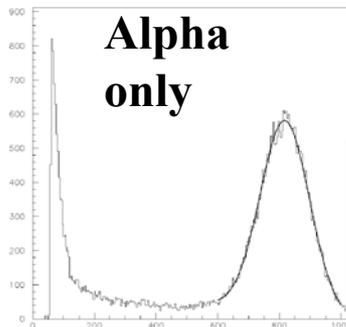
Scintillator Interaction Testing

**Test all glue types
and all parts**

**Ratio of Compton to alpha to take out
phototube variation**
