Quality Assurance –Factory Machines (2.5.3.3)

Daniel Cronin-Hennessy
For University of Minnesota

June, 2007

NOvA

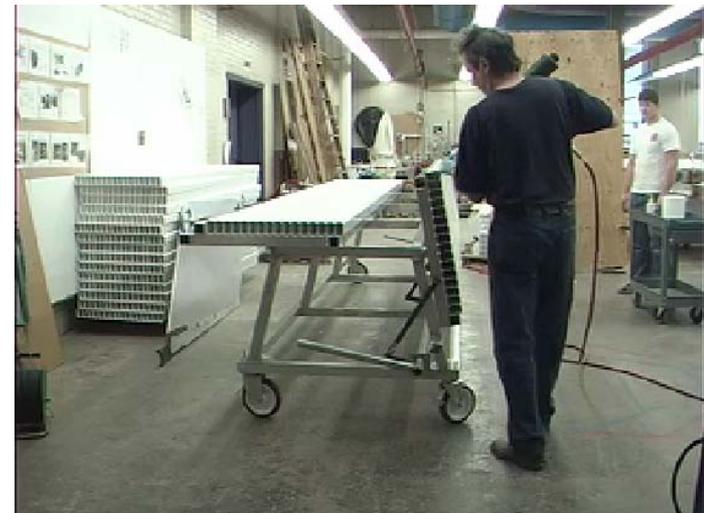
16-cell extrusions are bonded in pairs along length to produce 32-cell extrusion assemblies

QA must insure bond quality (adhering and glue thickness).

Glue samples are drawn from lots for standardized stress tests (**NOvA-doc1027 Nitti**)

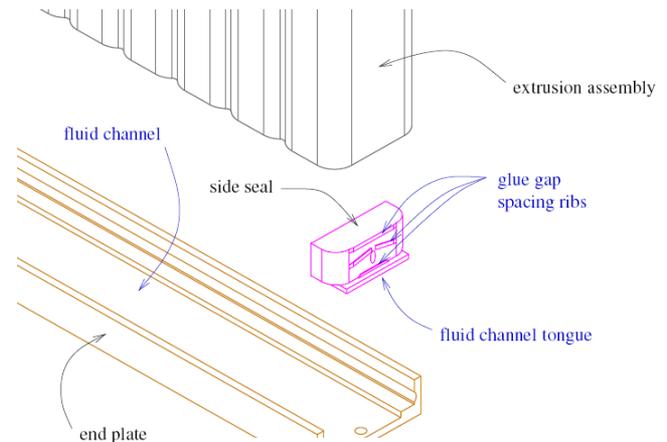
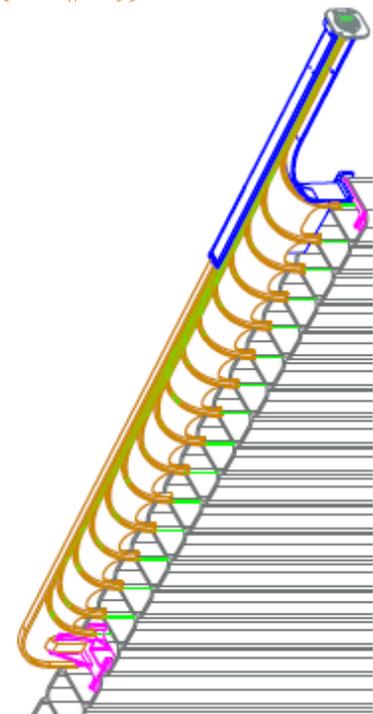
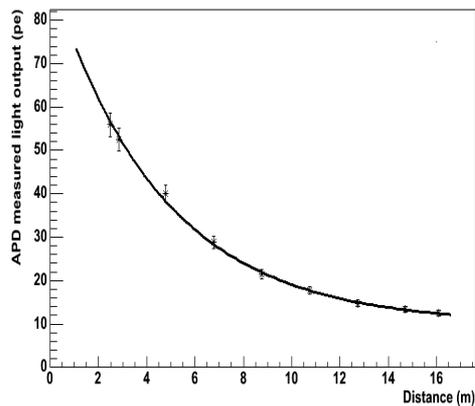
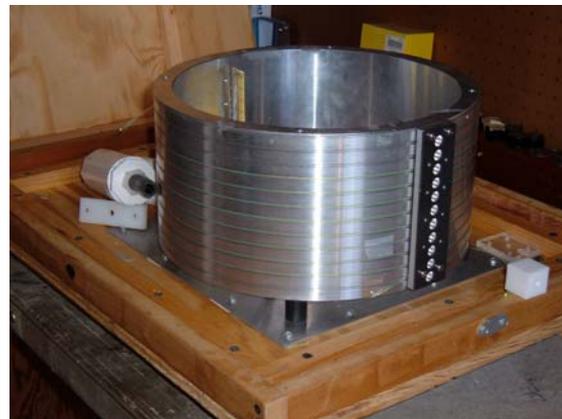
Manifold/End Seal Components & Fiber

Inspection of manifold and end plate assembly components
Manifold cover, racetrack, side/center seals, optical connector
Front/back covers ...

Fiber attenuation measured for each spool upon arrival.
First 10 meters taken from each spool.
Results stored in database.
Results used in fiber continuity check at later time.

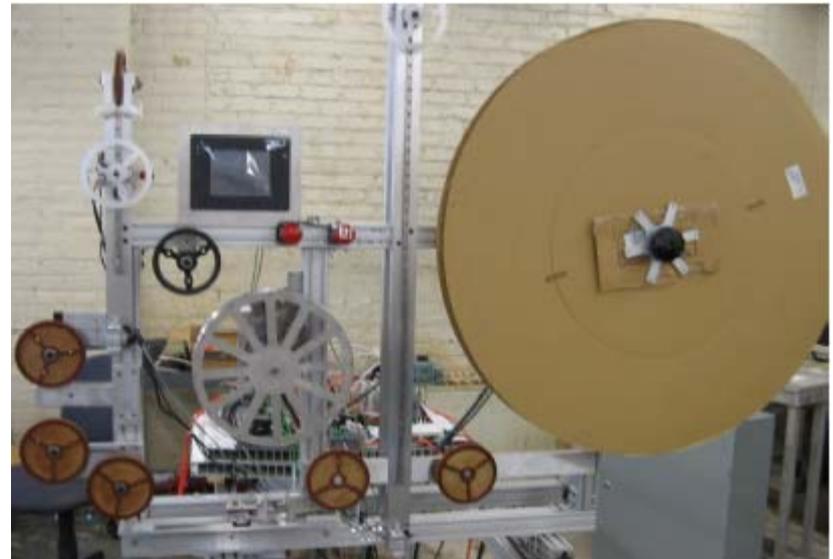
Fiber Stringing Machine

- Key assembly machine
 - Reels out extrusion length of fiber on to take-up reel
 - Vacuum “puck” pulls fiber through the extrusion.
 - Use of vacuum proof of principle demonstrated at UMN
 - Active tension control during routing
 - String pot for position sensing
- Machine in use.
- Details given in separate talk.

- *Automatic fiber/cell tracking
- *String pot allows cell tracking
- *Operator enters fiber registration
- *Data stored in database
 - Allows comparison of spool calibration from Michigan state with light transmission tests at factory

- The quality of the fly cut and damage to fibers are probed with a fiber continuity test.
 - Both the facing machine and stringing machine have been in use during R&D

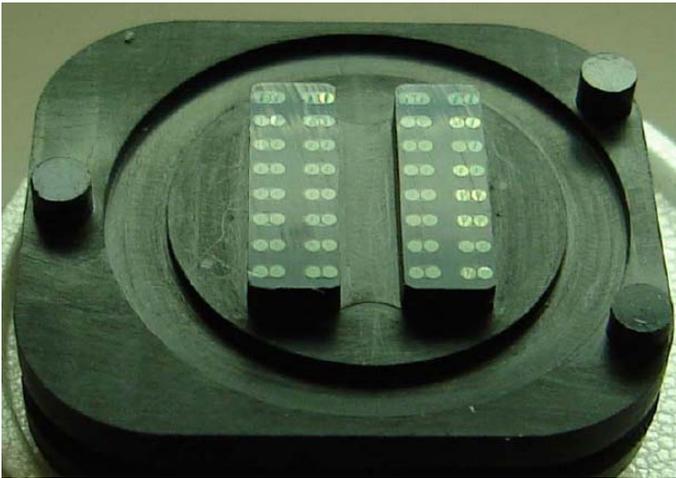
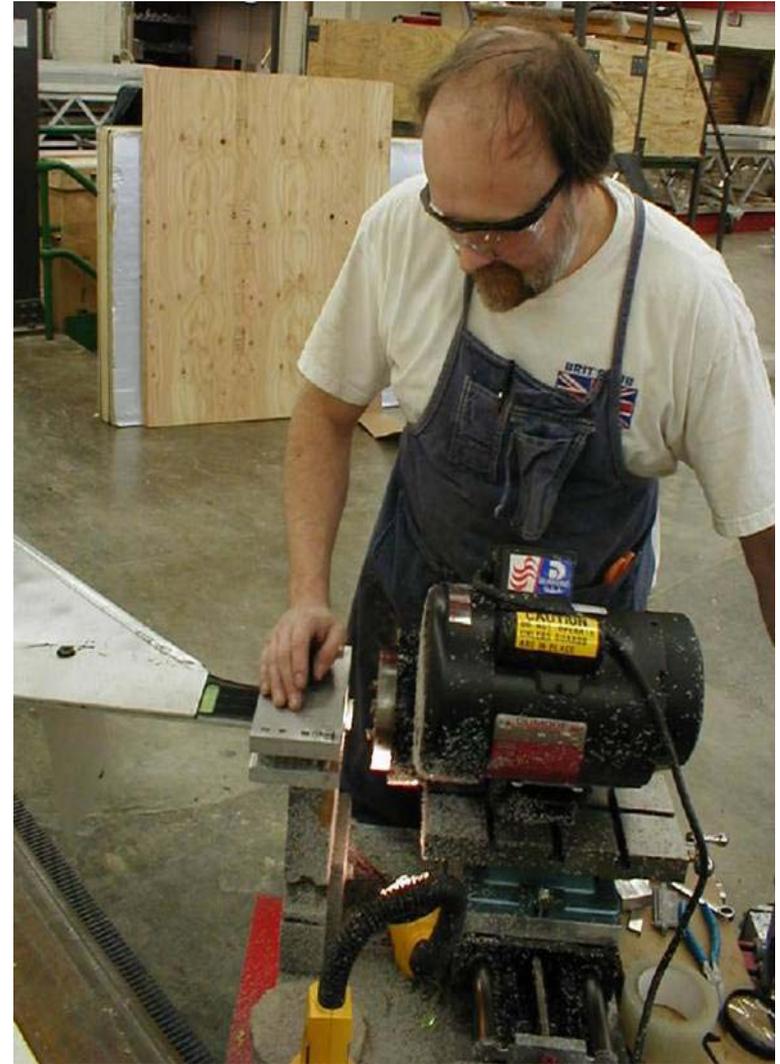
Fiber Facing Machine

- Provides flush cut of fiber at the optical connector.
- Based on MINOS machine.
 - Dumore tool post grinder
 - Coupled to Thomson movement
 - &Linear table
 - Duo diamond tips on drum
- Design allows 2/3 additional cuts.
- Fixturing needs some improvement.

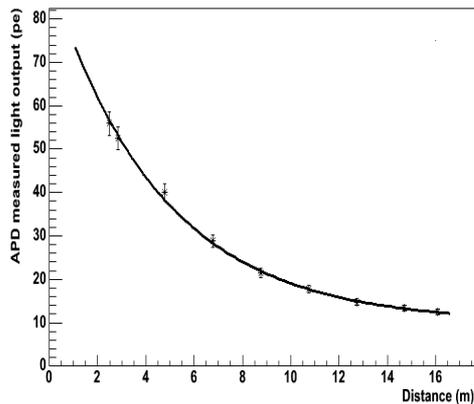
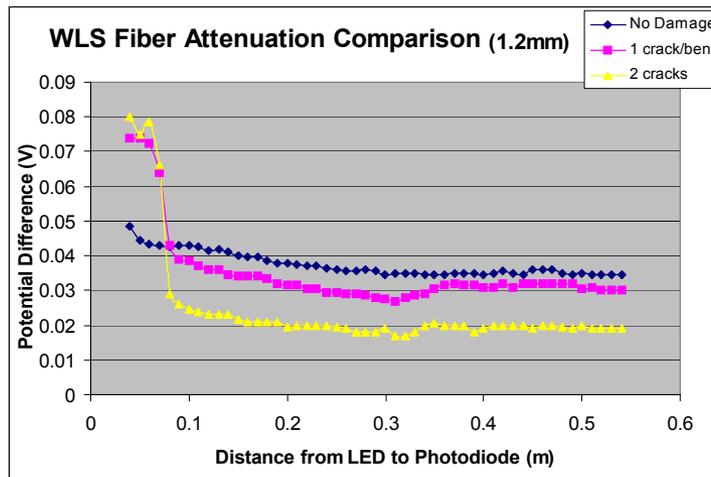
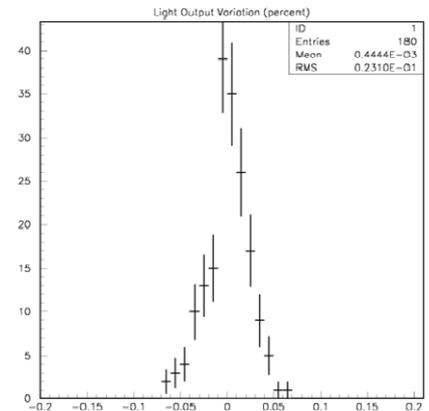
QA: Fiber Continuity

Check light output after module is complete (after fiber facing).

Compare to spool calibration.

Determines whether any damage to fiber occurred to during module assembly.

Must interface to 64 fiber ends of completed module.

“Typical” loss for kinked fiber → 25%.

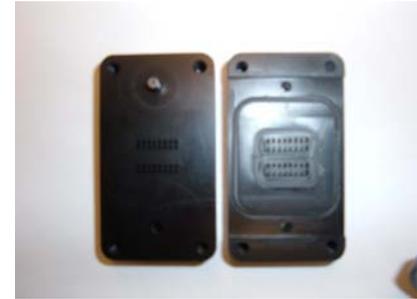
QA: Fiber Continuity Device

Optical Connector

Vertical movement
For placement at module

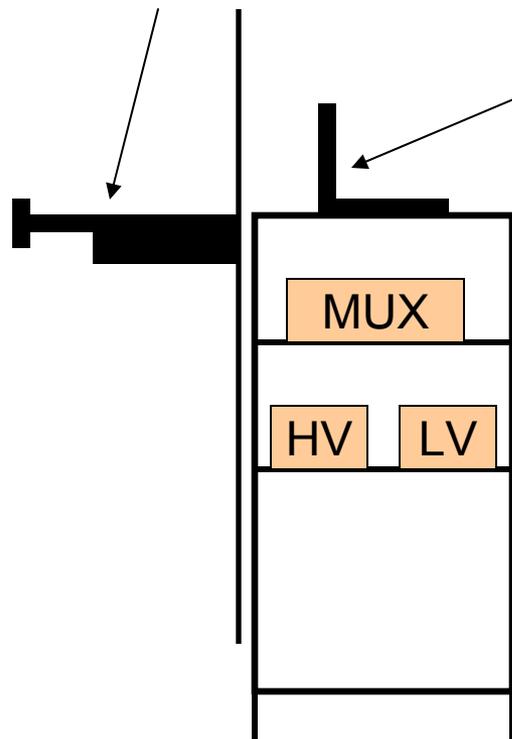
Results display (Labview)

Hamamatsu S8550
(APD array)
Agilent 34970A
(MUX)

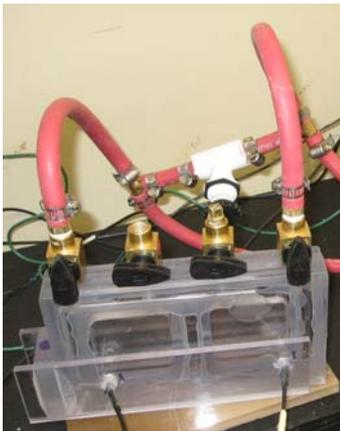
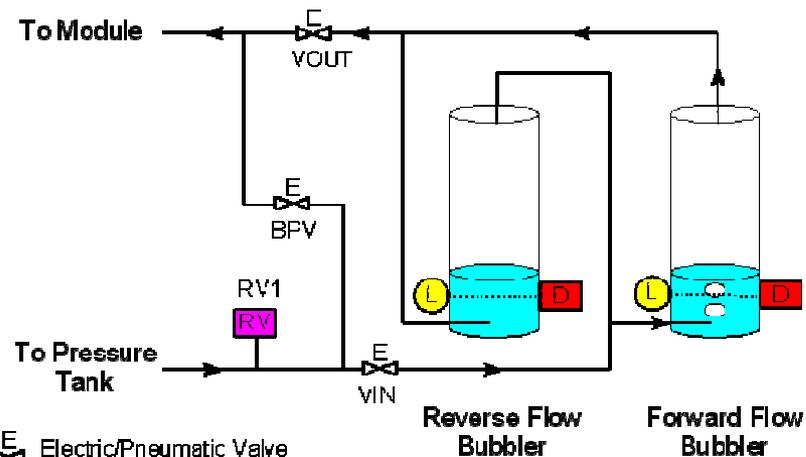
QA: Leak Test

Designed to identify 3 micron leaks during module production.

Executed after the glue cure.

Duration 12 hours.

Bubble bottle

Electric/Pneumatic Valve

Relief Valve

IR Photodiode/LED
Bubble Counter

Module Fill: VIN, VOUT closed, BPV open
Module Test: VIN, VOUT open, BPV closed

- Discovery of faulty glue seals is critical for the success of NOvA module fabrication. Long-term dye test demonstrate our ability to manufacture high quality seals. Bubble bottle leak detection will be employed to detect faulty seals.

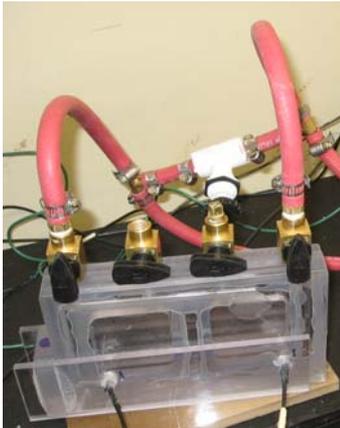
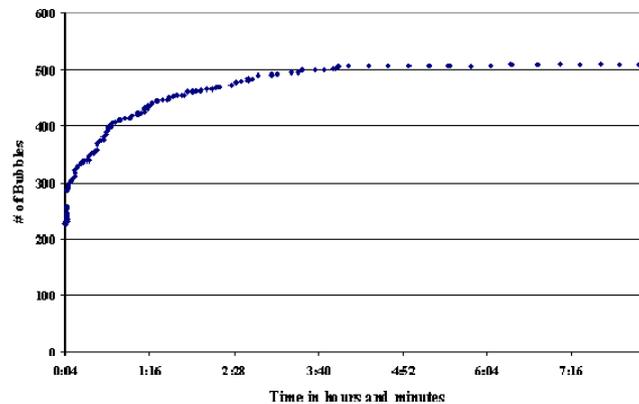
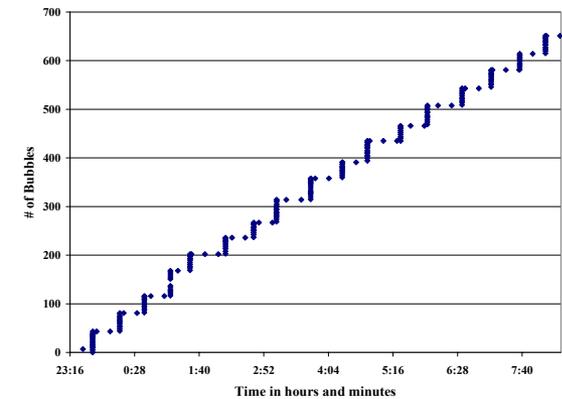
QA: Leak Test

Leak detection (3 micron holes) demonstrated in a factory setting.
Optical counter for bubbles.

Far right: Number of bubbles counted versus time for 6 micron hole.

Middle: Some settling time required.

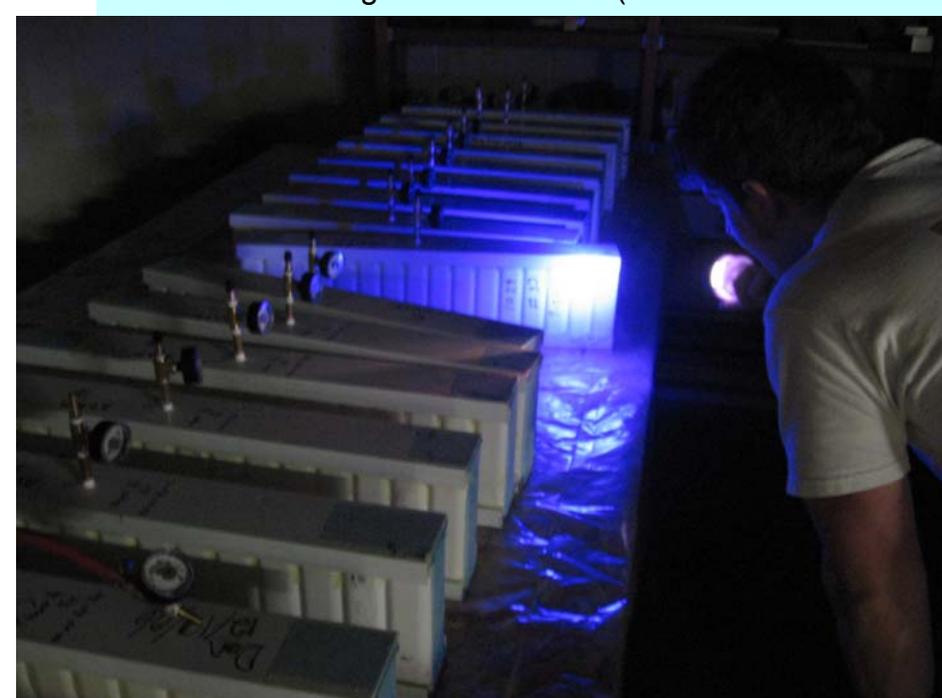
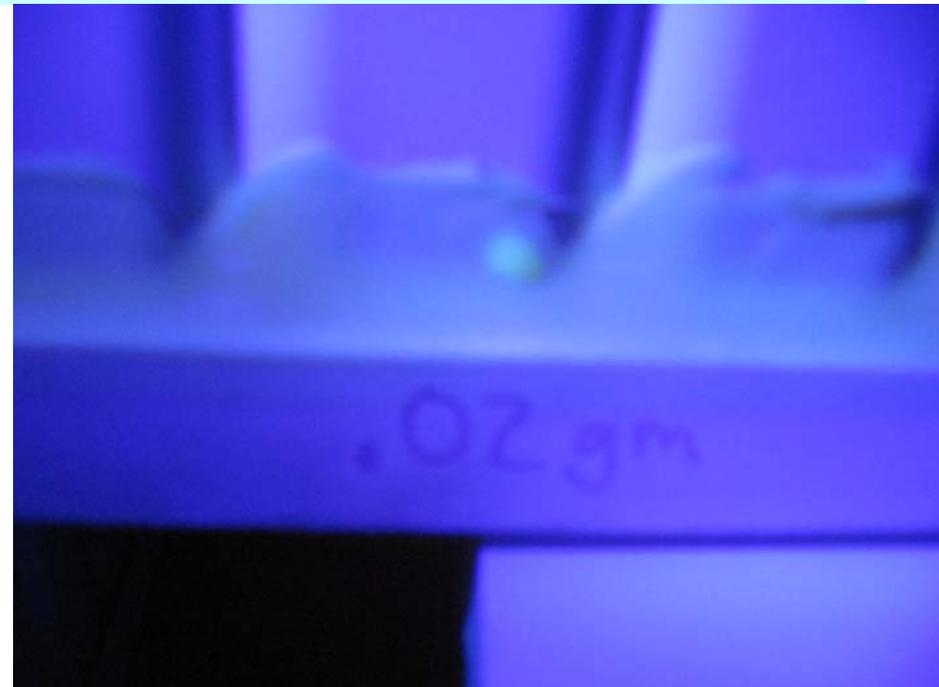
QA: Leak Test

Long term dye leak test. **NOVA-doc 1031Sword et. al.**

Fluorescent dye added to water in module.

Shown are studies of the first 57 seals (6 inch)

Right plot is example of smallest dye amount detectable (conservative 0.02 gm)

3 months with no leaks detected

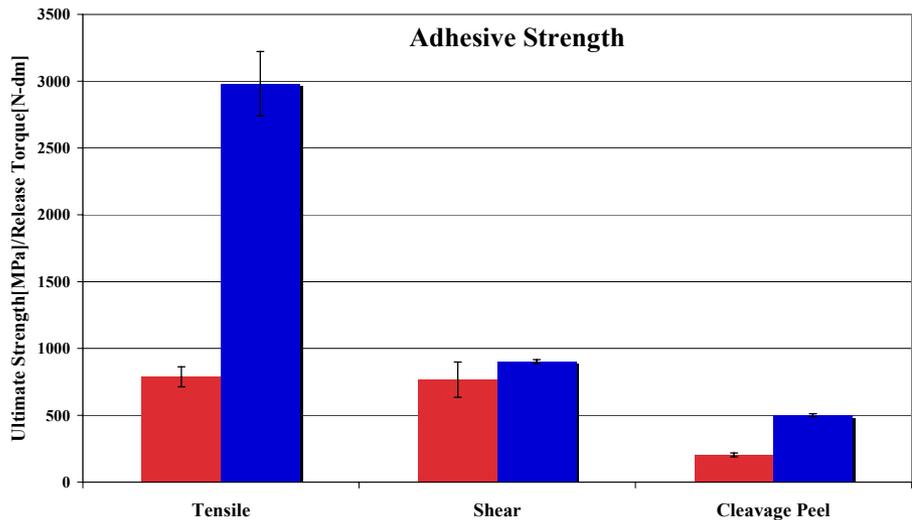
Glue

- Standard strength tests perform for each lot of glue.
- Shown are results from NOvA glue (Plastic Welder and 8216)
